**Tofte Ranger District
Superior National Forest**

September 2011

Snag vs. Human Accident Facilitated Learning Analysis Team

Snag vs. Human Accident Chronology September 19, 2011

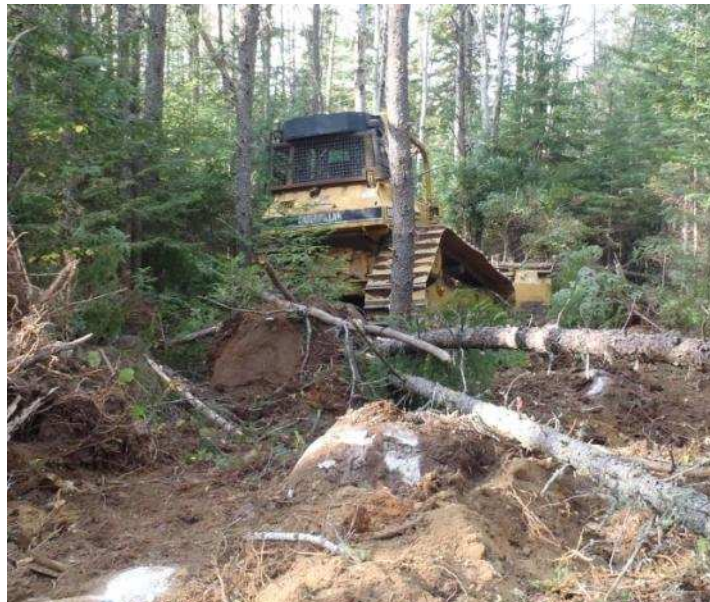
At approximately 1540 (8 hours into a 12 hour shift), the lead dozer boss (DB1) and dozer operator (DO1) stop short of a 90 degree jog in the line, angling the dozer 45 degrees away from the line, with two jack pine snags in the left rear blind spot of the dozer (See Photo 1).

Photo 1: Close-up of snags and the D1 after the accident. Note the rocks, difficult terrain, vegetation, and the blind spots in the enclosed cab of D1.

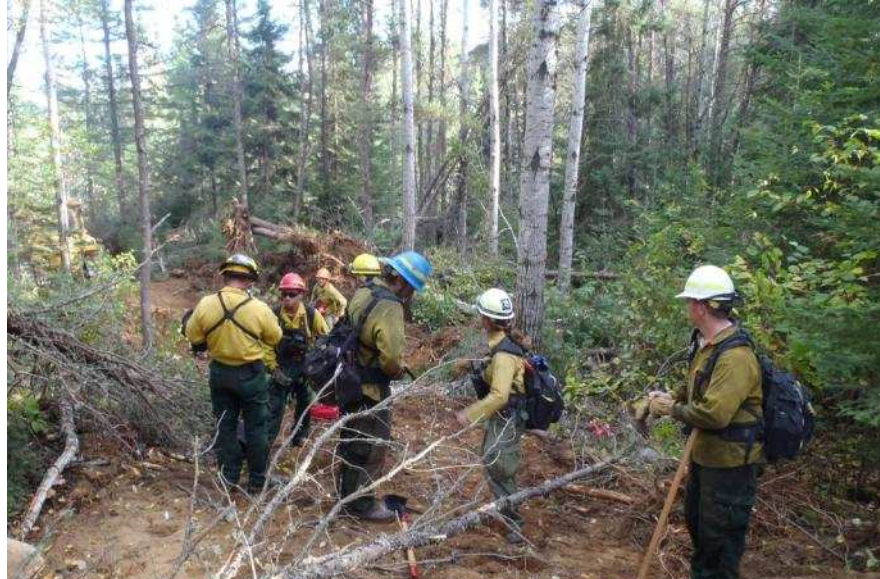
Photo 2. Picture of the hill slope where the accident occurred looking down from the right angle corner in the fireline. Note the dead tree in the fireline that struck D2. The dozer is moving back out to the road.

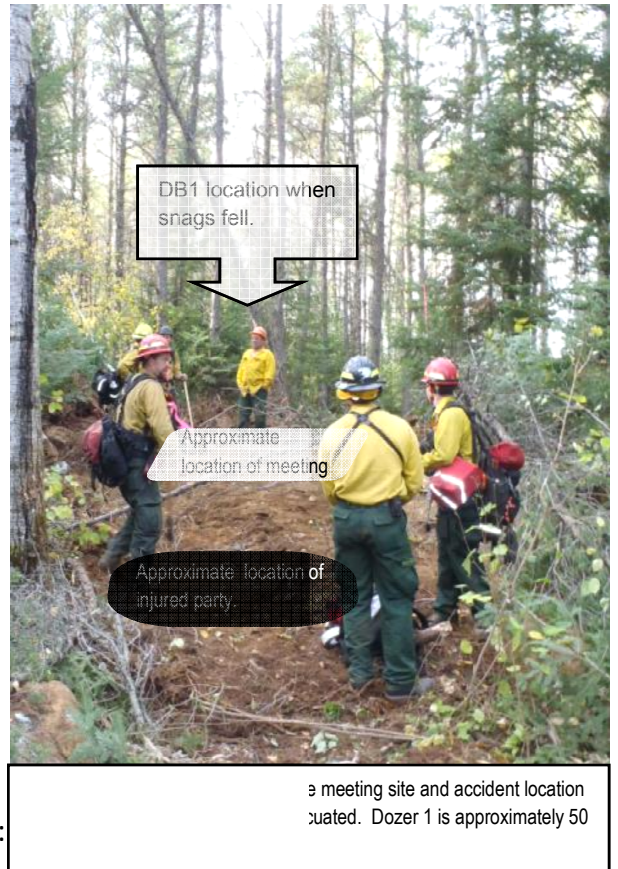
- ❖ **1540**--DB1 needs supplies, calls DB2, who was between DO1 and DO2. DB2 stops DO1. Stops beyond the top of a right angle jog in the line (See photo 3).
- ❖ DB2 and DO1 meet at the top of the rise between two right angles and begin to discuss operations for the rest of the day. DB1, who is ahead of D1 by 200-300 feet joins them.
- ❖ A couple of minutes later, DO2 arrives at the bottom of the slope approximately 100 feet away, stops his dozer, and walks up to join the meeting.

- ❖ DB1, DB2, DO1 and DO2 discuss operations for the rest of the day. Conversation wraps up and DB2 leaves the site to meet TFLD(t), DO1 returns to his dozer, DB1 and DO2 remain at the site and watch DO1. (photo 3).

- ❖ DO1 begins to back up his machine. As soon as the back-up alarm goes off, DB1, recognizing that the roots of two snags adjacent to DO1 have been cut off and are in danger of falling, takes a step towards DO1 and begins waving trying to get his attention to stop, this is unsuccessful. DO1 hits the snags and they begin to fall. DB1 turns and yells at DO2 to run. They turn to run and the smaller snag hits DO2 in the head and back while running away (photos 2 and 3). DB1 gets DO1 attention to stop after DO1 has positioned the dozer for a 90 degree angle in the line.
